Report to the NM 14 Citizens Advisory Committee (pro bono)

Re: Site Inspection concerning *Record of Agreement* and current Maintenance Issues

From: Kim Sorvig
Licensed NM Landscape Architect
Research Assoc. Professor, UNM School of Architecture & Planning
Member, NM 14 CAC

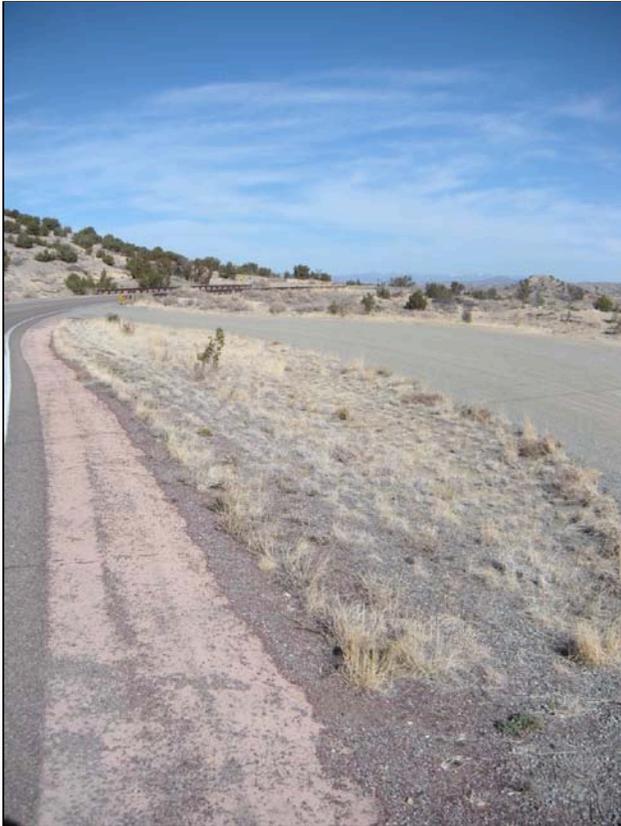
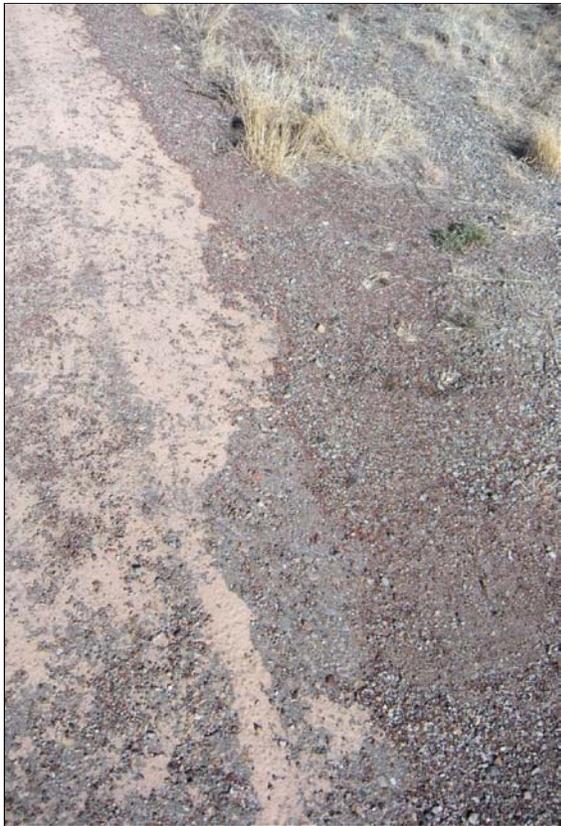
At the scenic pullout in the S-curves north of Madrid (and many other locations), revegetation has been very successful on the re-graded roadside. Reclamation Seed Mix was specified by Sites Southwest and applied to the R.O.W. The species from this mix that are evident at this dormant time of year are native grasses (wheatgrass, blue grama, galleta, ricegrass, dropseed, needlegrass) and *Penstemon palmeri*. Shrubs such as Rabbitbrush, Apache Plume, Winterfat, and Saltbush also appear to have been successfully re-established. Other species are likely to be observed in season. (The right-hand photo shows experimental coloration of the shoulder, requested by CAC but eventually dropped from the contract; it has proved quite durable.)

The Reclamation Seed Mix with ‘duffing’ was carefully chosen and appears to have been successful. It meets the soil-stabilization requirements of NEPA, and does so at a lower cost than any other soil-stabilizing method. It should therefore be maintained to ensure continued stabilization. This includes duffing and re-seeding damaged areas, mowing AFTER the majority of species have set seed, and mowing AROUND shrubs unless they become so large as to pose a traffic hazard.

No maintenance activity should cover or uproot any of the revegetation plantings. Existing ground cover should only be covered by placement of soil or paving IF there is a deliberate need to create a pull-off for a specific reason (such as mailboxes). Unplanned pullouts should not be created by NMDOT, and if the public pulls off in unplanned locations, NMDOT should discourage this by berming and planting, rather than encourage it by spreading base course or soil.

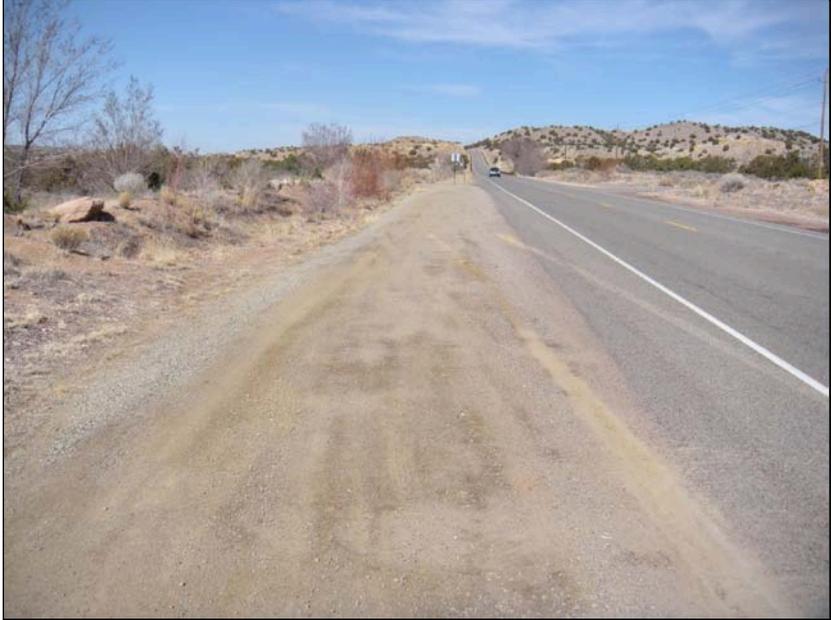
At the deliberate pullout south of Garden of the Gods, the pullout is visually distinct from the roadway pavement, is no wider than a single vehicle, and is bounded by a berm.

These were deliberate design and construction choices. They achieve their intent: to keep the roadway visually as narrow as possible. This has been shown to cause voluntary reduction of speed by drivers who perceive the road as narrow, thus reducing severity and likelihood of crashes. No new *descansos* (marking fatalities) have appeared between Madrid-Lone Butte since project completion.

(Invasive Salt-cedar was imported with soil at this location. It should be removed before it spreads further.)

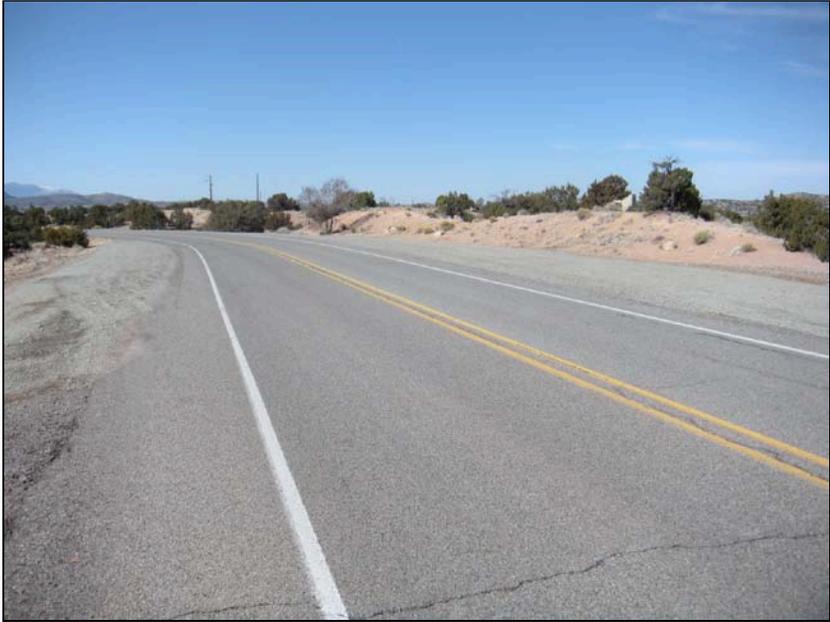
By contrast, at the crest of the hill just south of CR 42, placement of base course over disposed asphalt has visually widened the road, so that it appears four lanes wide. The base course is visually very similar to the pavement, appearing as a single surface. This destroys all traffic-calming benefits.

All maintenance must keep the pavement visually distinct from the rest of the R.O.W. in material & color.

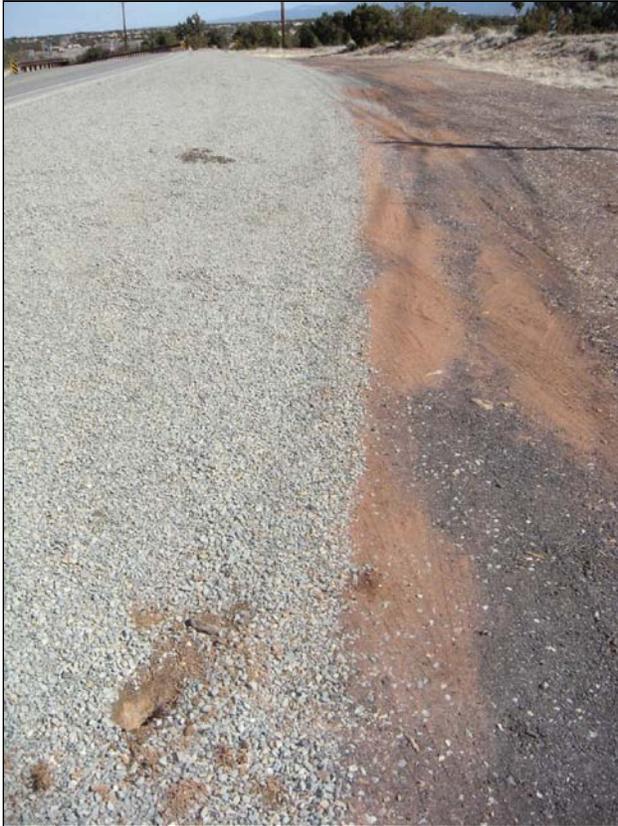
At NM 42 (LEFT), small pits dug at random locations into the new base course appear to show that the waste asphalt was removed (except for trace amounts) before base course was placed.

This represents a good-faith effort to remove the disposed waste material as fully as practicable.

In this area, the base course is ready to be mixed with 'duff' or topsoil and re-seeded. This should reproduce the successful vegetation that was seeded during construction.

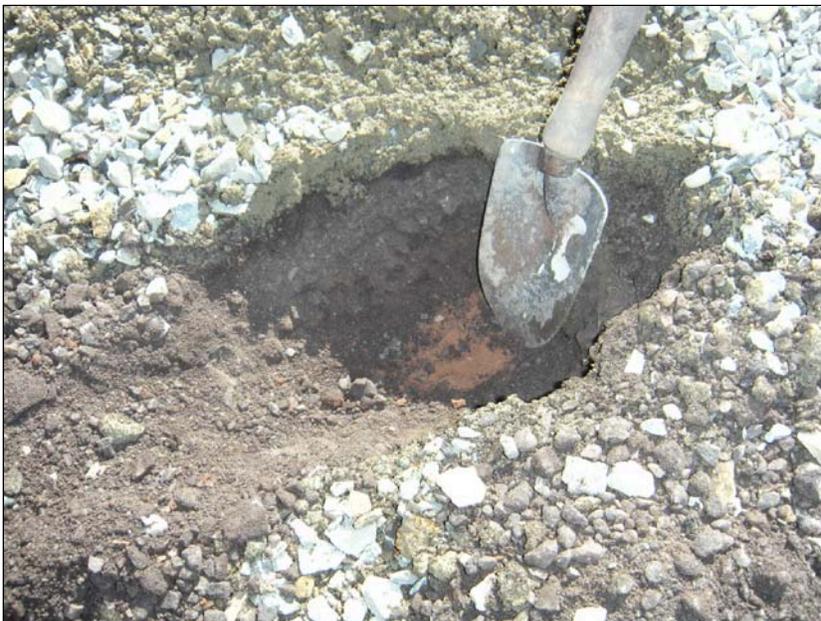
However, south of CR 42 (West side, near crest of hill) similar pits showed that a couple inches of base course were covering four inches of remaining asphalt, over what appears to be red clay from excavation at General Goodwin culverts. (This could be local soil.)

Similarly, bark over asphalt was found south of Lone Butte (west side).

Cosmetic cover-up is not acceptable.

Waste asphalt usually contains contaminants from vehicles, and causes persistent damage.

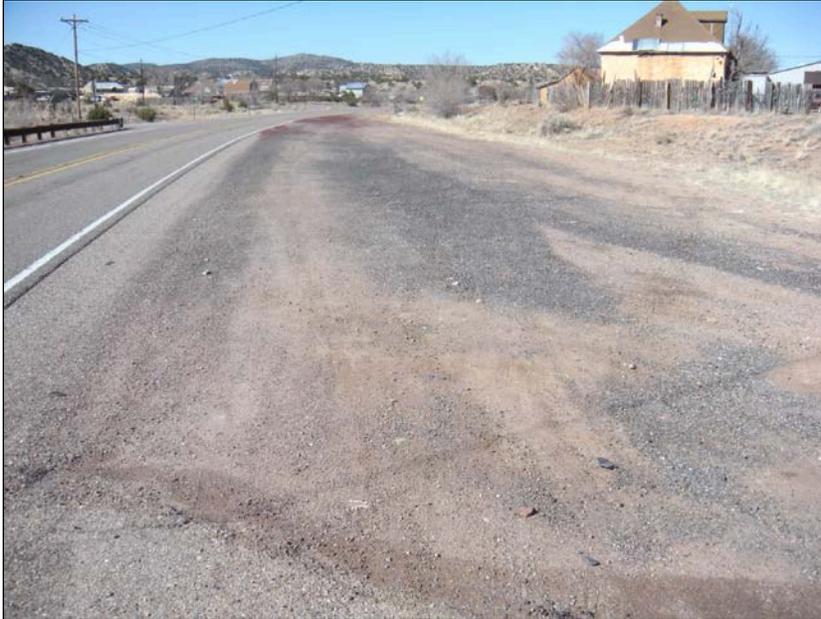
Near the NMDOT yard at Cerrillos (BELOW), there is an area that has been used for stockpiling. Unlike the R.O.W. areas that have been properly maintained along NM 14, this section shows no revegetation, despite many years of exposure.

Disposal of waste asphalt at the edges of pavement or elsewhere in the R.O.W. would have similar long-term

effects: soil that grows no vegetation, and that therefore creates runoff and sedimentation. In addition, spills of gas, diesel, antifreeze, and other vehicle fluids, as well as cargo spills, may add contaminants. Like all petroleum products, asphalt is itself a serious soil contaminant any time it is spread beyond areas of deliberate pavement.
